Project

Audi 4000 CS Quattro

Part 8:

Suspension component overhaul

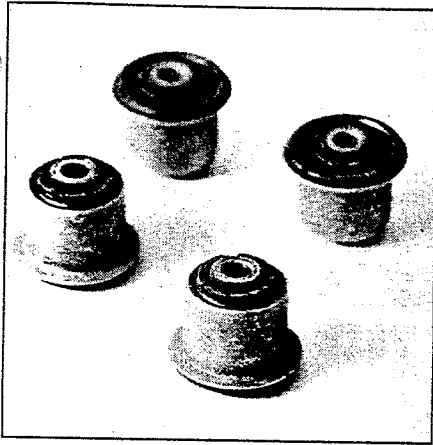
The inner control arm bushings are the Achilles heel of aging Audis.

The hardest part about refurbishing the control arm is removing the bushings. It is easy to envision removing the bushings with a pair of sockets (or press dies) on either side of the bushing and pressing with a hydraulic press or vise. Easier said than done. The press I have access to is simply the wrong size. If it was wider, the whole arm could be placed between the rails. If it was smaller, the "y" portion of the control arm could be placed around the rail and the bushings pressed.

Neither of these two methods work all that well. The machine shop we took the control arms to suggested collapsing the tapered portion of the bushing on four sides and driving the bushings out with an air hammer. This requires a steady hand and a bit of finesse, but it seemed to work okay. Bear in mind that this is far from ideal. In a perfect world, you'll have all of the various dies mandated by the factory repair manual and suitably sized hydraulic press. When you have to make do, you find your own solutions.

Installing the new control arm bushings is easy compared to the grief involved with removing the old ones. Coat the outside of the new control arm bushings with a little anti-seize or similar friction-reducing compound. Place the control arm into a press or vise. Press in the new bushings, taking care not to damage them. As the bushing begins to pass through to the other side, you'll have to provide clearance in order to fully seat the bushing.

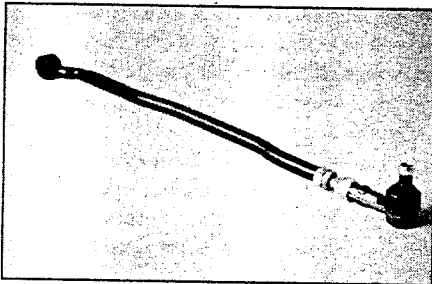
Tie rod ends can be replaced individually or as a complete tie rod assembly.

With the control arms sorted out, you can now turn your attention to the tie rod ends. Before removing them, center the steering wheel. Not only should the wheel be centered, the amount the wheel can be turned in either direction from center should also be the same. The tie rods are removed by loosening the nut at the strut and pressing off. At the rod coming from the steering rack, simply unscrew. When refitting, set the toe as best as possible. If you know any racers, they'll probably have a

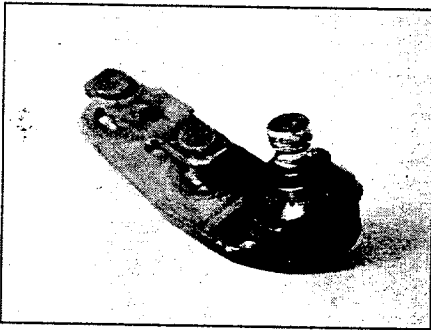
The front ball joints are angled towards the front. The reference line facilitates positioning of the new unit.

Remove the ball joint and clean and paint the control arm. To facilitate reinstallation of the ball joint, measure or mark its position. When the new one is installed, you'll at least have it in the ball park (more like in the sta-

dium parking lot). The ball joints on the 4000q should be angled toward the front.

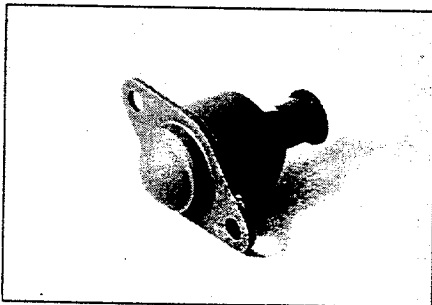
A new Audi rear ball joint.

front, the biggest difference being the mounting of the ball joint. To separate the ball joint from its mounting on the control arm, you can use a small puller or simply lever it away. The ball joint is removed from the bottom of the strut by fabricating a flat piece of steel about 1.0 x 3.5 x 0.75-in. thick. The piece should have a hole in the center large enough to fit onto the protruding ball joint stud. Fasten to the ball joint with a nut. Screw in two 8mm x 40mm bolts into the mounting holes for the ball joint. By reversing the direction of the bolts and bearing against the steel bar, you can extract the ball joint. Or, wedge in a chisel between the ball joint and the bottom of the strut.

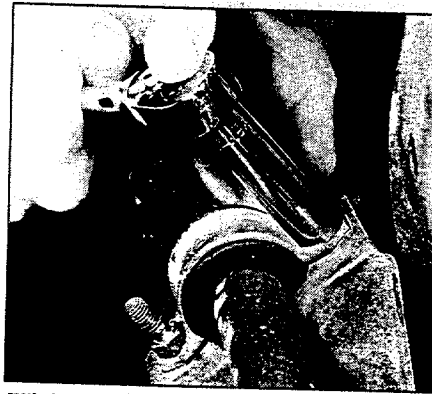
While we were there, we decided to change the anti-roll bar bushings as they are easily accessed.

The sway bar bushings are easily removed by pushing out the metal sleeve. Cut the bushing with a utility knife and push the remainder through with your finger. The factory manual makes a big production over removing the bushings; just do it.

To install the sway bar bushings in the control arm, spray the rubber with silicone spray and push the bushings in with a flat-bladed screwdriver. It takes a bit of cursing to get them in, but it's still better than buying all of the unnecessary dies that the factory manual calls for. If you push too hard, you will tear the new bushings. The bushings in the end of the sway bars are replaced in a similar manner. **Warning: DO NOT ACCIDENTALLY BREATHE THE SILICONE FUMES** (or intentionally, for that matter). The silicone when
